**UNITED STATES DISTRICT COURT
SOUTHERN DISTRICT OF NEW YORK**

----- X
CHEVRON CORPORATION, :
 :
 :
 Plaintiff, : Case No. 11 Civ. 0691 (LAK)
 :
 v. :
 :
 :
 STEVEN DONZIGER, et al., :
 :
 Defendants. :
 :
----- X

WITNESS STATEMENT OF JAMES I. EBERT, Ph.D.

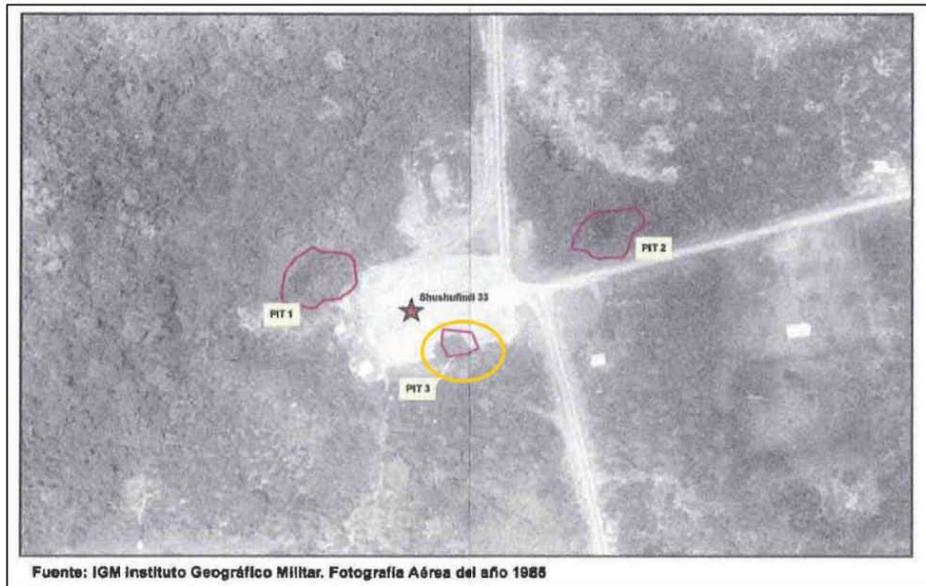
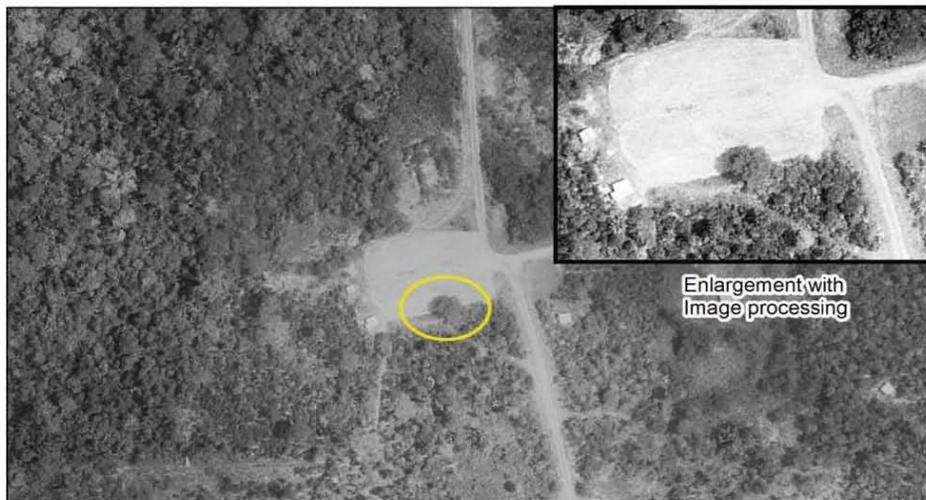
Figure 1: Shushufindi 33 Well Site

21. For example, a 1985 IGM aerial photograph of Shushufindi 33 Well Site from Anexo E of the Cabrera report shows three alleged pits bounded with colored lines (see top photo in Figure 1 below). However, a review of an enlargement from a higher quality scan of the same IGM photo (#44409) shows a tree and its shadow have clearly been identified as “Pit 3” (see bottom photo in Figure 1 below).

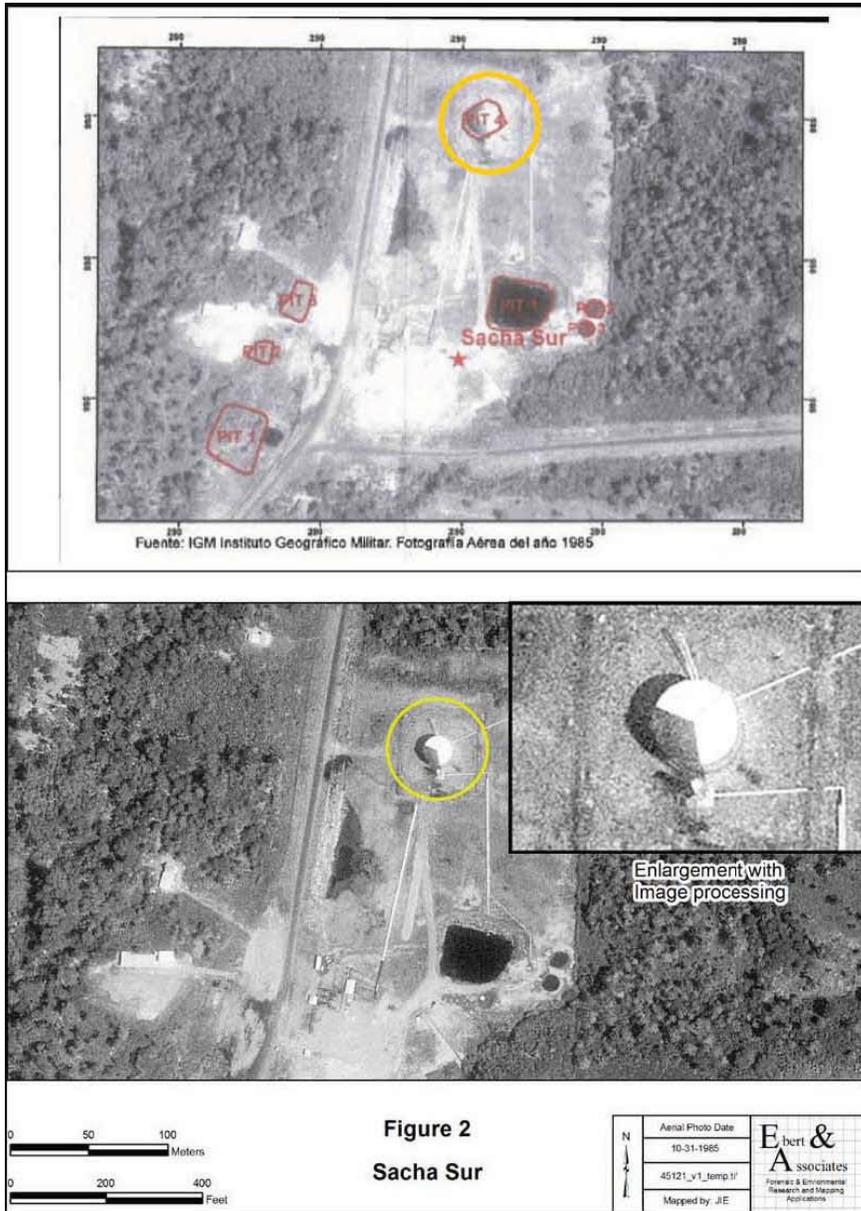
Figure 2: Sacha Sur Station

22. Similarly, a 1985 IGM aerial photograph of the Sacha Sur Station well site from Anexo E of the Cabrera report purports to identify pits (see top photo in Figure 2 below). However, a much higher quality scan from the same 1985 aerial photograph (IGM

#45121) shows that “Pit 4” is an above-ground tank with a dark shadow (see bottom photo in Figure 2 below).
